ANALYSIS OF DOMESTIC WATER SYSTEM

Grandview Court and Parkview Court
10523 & 10533 UNIVERSITY DRIVE
SURREY, BC

June 19, 2014

**RE: Domestic Water System Assessment at Strata Plan LMS 1328 Grandview Court and
Parkview Court – 10523 & 10533 University Drive, Surrey, BC**

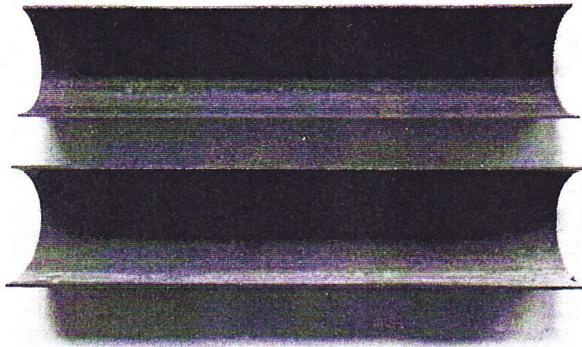
An example of uniform corrosion and cold-water pitting is seen in sample A1 (refer to Photo 1). Uniform corrosion is a general form of corrosion where the entire surface of the pipe wall is thinning at a uniform rate. A tarnished copper surface and shallow narrow pits characterize uniform corrosion and cold water pitting respectively.

Photo 1. Pipe Sample A1 – Cold Main

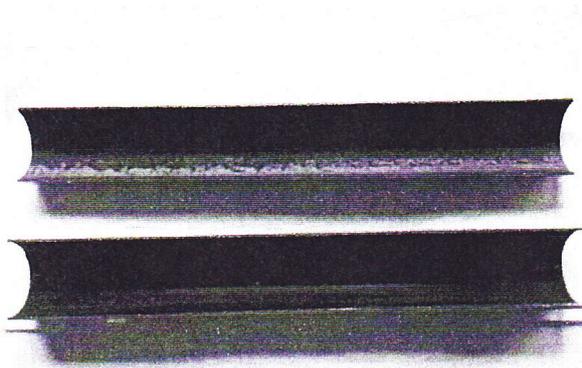
Photo 3. Pipe Sample A2 – Hot Main

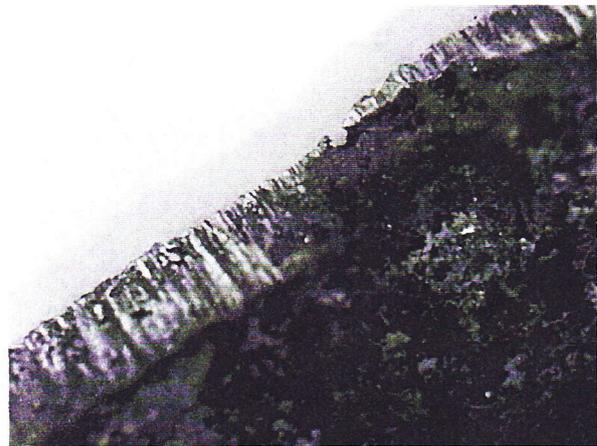
Photo 4. Pipe Sample A2 – Pin Hole

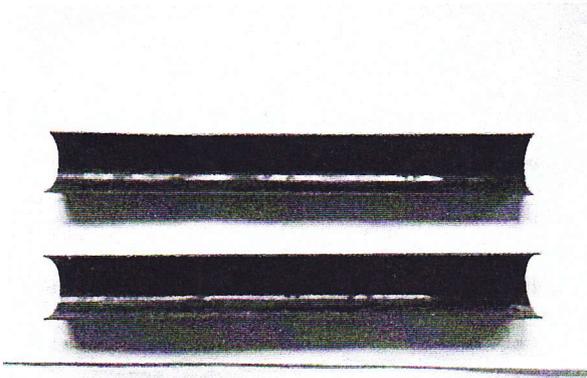
Photo 7. Pipe Sample A4 – Hot Riser

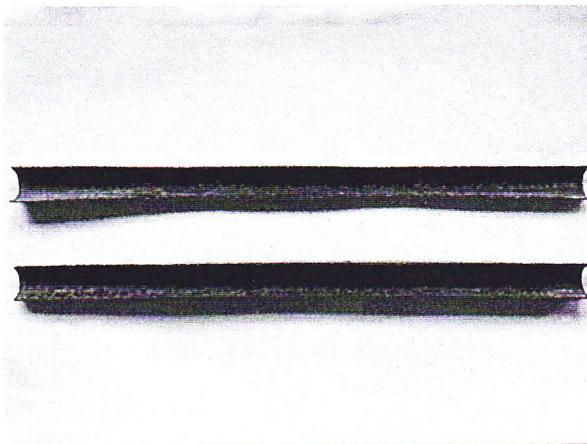
Photo 9. Pipe Sample A5 – Recirc

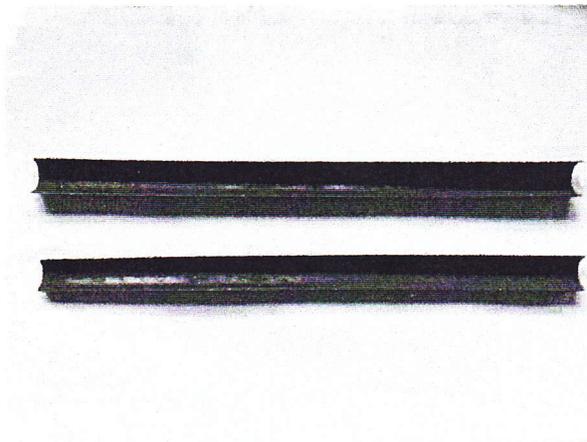
The recirculation pipes are in the worst condition due to the constant circulation of water throughout the day and high temperature. See sample A6 and D5 for examples.

Photo 11. Pipe Sample A6 – Recirc

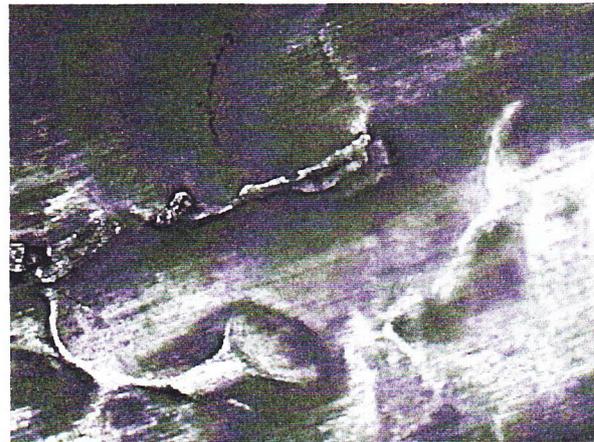
Photo 12. Pipe Sample A6 – Velocity Wear and Mounds

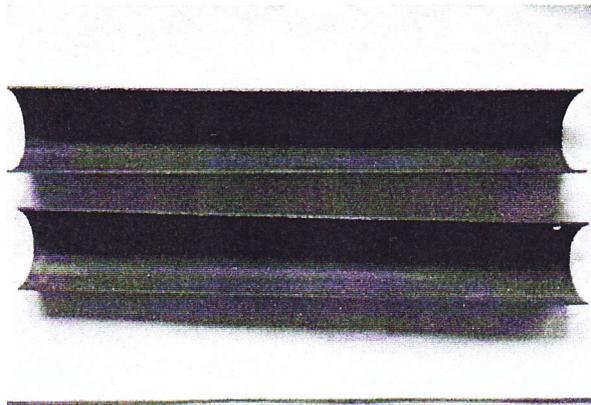
Photo 13. Pipe Sample B1 – Cold Main

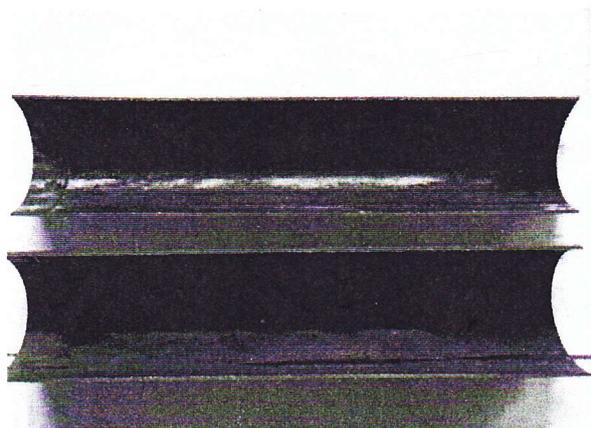
Hot water pipes, such as Samples B2 represent typical uniform to severe velocity scouring and hot water pitting. Such deteriorations are characterized by deep pits of small cross section that are capped by greenish-black mounds and water-swept marks (refer to Photo 15). The causes of such corrosion are usually high velocity water and high temperature (> 60 °C).

Photo 15. Pipe Sample B2 – Hot Main

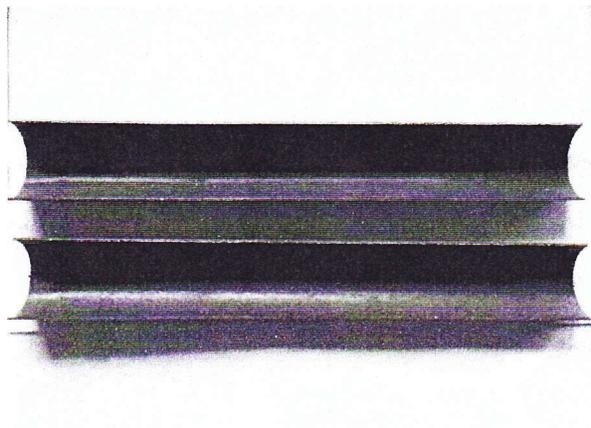
Photo 17. Pipe Sample B3 – Cold Riser

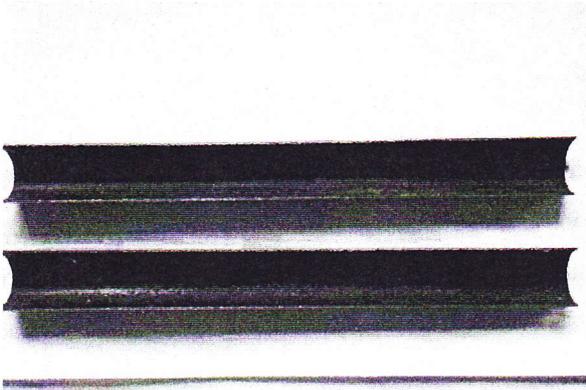
Photo 19. Pipe Sample B4 – Hot Riser

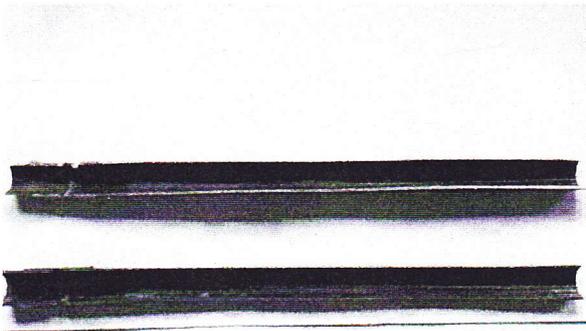
Photo 21. Pipe Sample B5 – Recirc

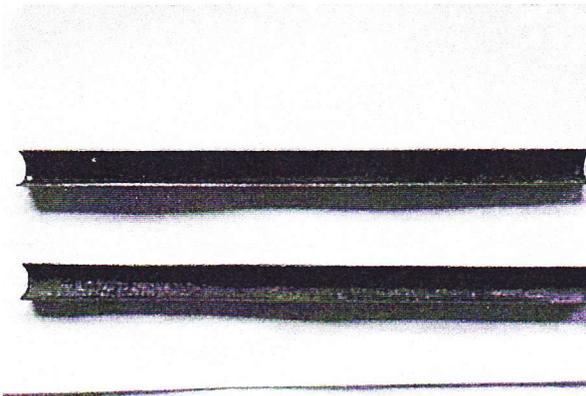
Photo 23. Pipe Sample B6 – Recirc

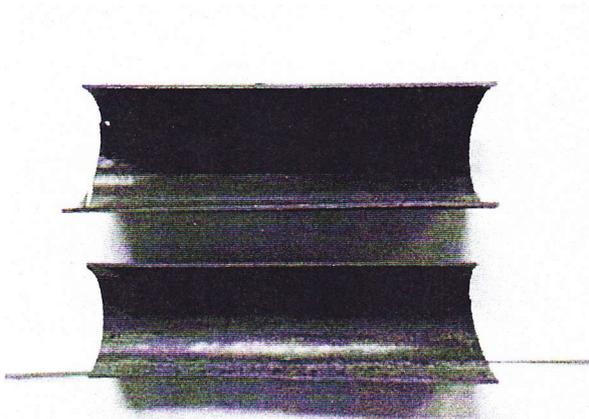
Photo 25. Pipe Sample C1 - Hot Riser

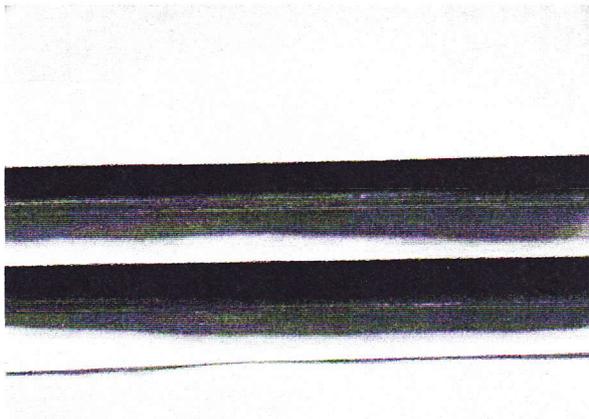
Photo 27. Pipe Sample C2 - Hot Riser

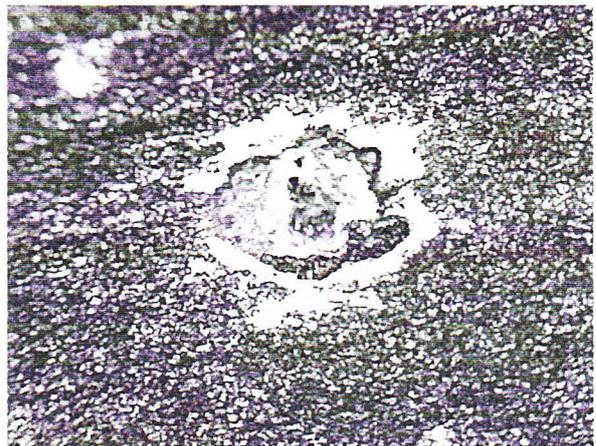
Photo 28. Pipe Sample C2 - Deep Pit

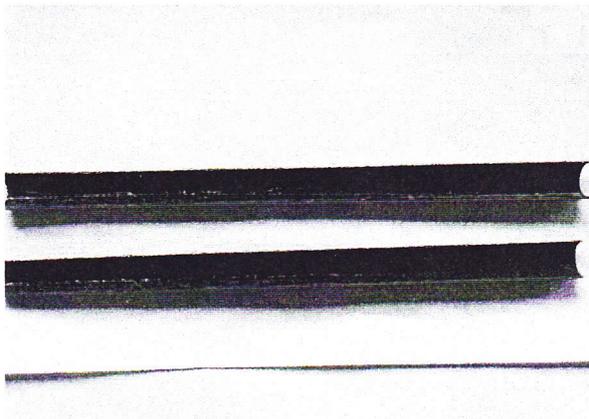
Photo 29. Pipe Sample C3 - Recirc

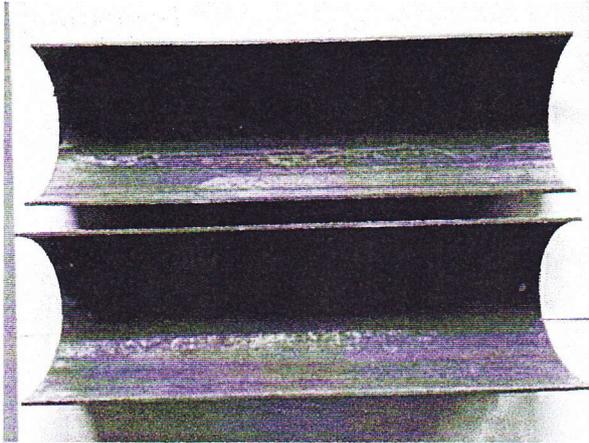
Photo 31. Pipe Sample D1 – Cold Main

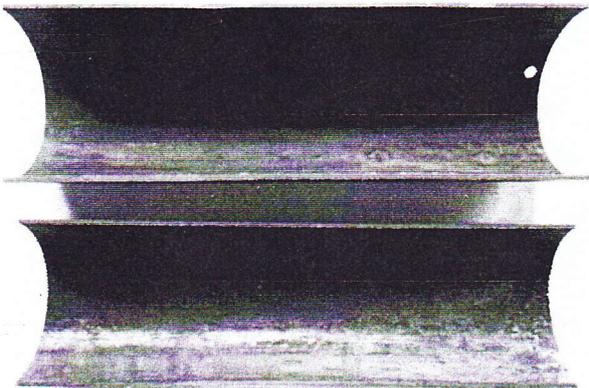
Photo 33. Pipe Sample D2 – Hot Main

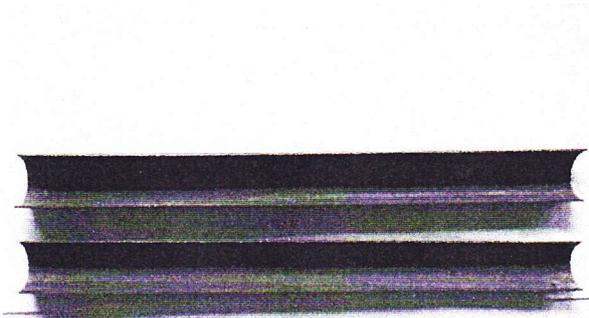
Photo 35. Pipe Sample D3 – Cold Riser

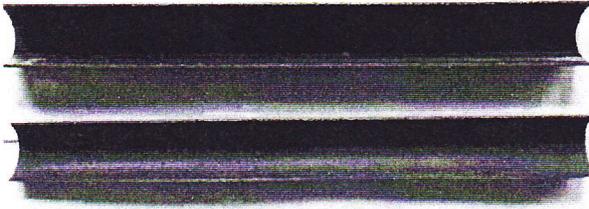
Photo 37. Pipe Sample D4 – Hot Riser

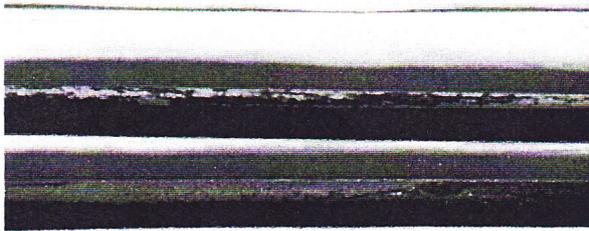
Photo 39. Pipe Sample D5 – Recirc

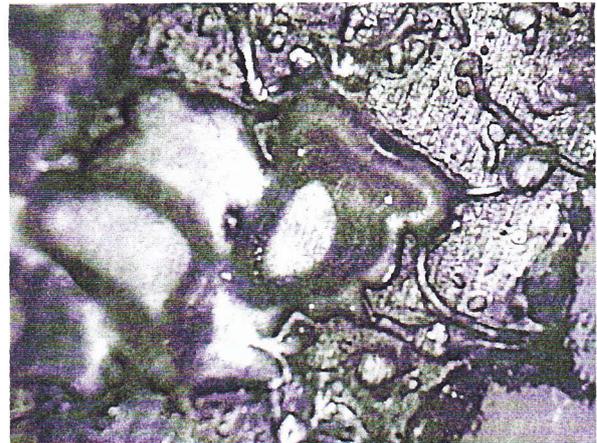
Photo 40. Pipe Sample D5 - Severe Corrosion and Deep Pits

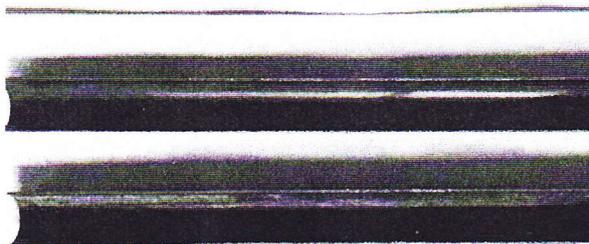
Photo 41. Pipe Sample D6 – Recirc

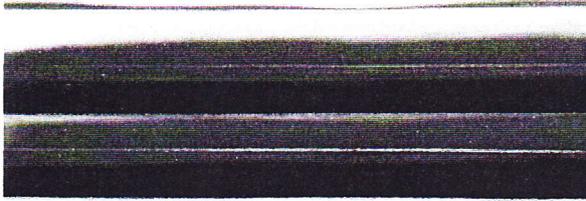
Photo 43. Pipe Sample E1 – Hot Main
